**BLACKSTONE RIVER BASIN
AUBURN, MASSACHUSETTS**

**UPPER STONEVILLE DAM
MA 00196**

PHASE I INSPECTION REPORT NATIONAL DAM INSPECTION PROGRAM

APRIL 1979

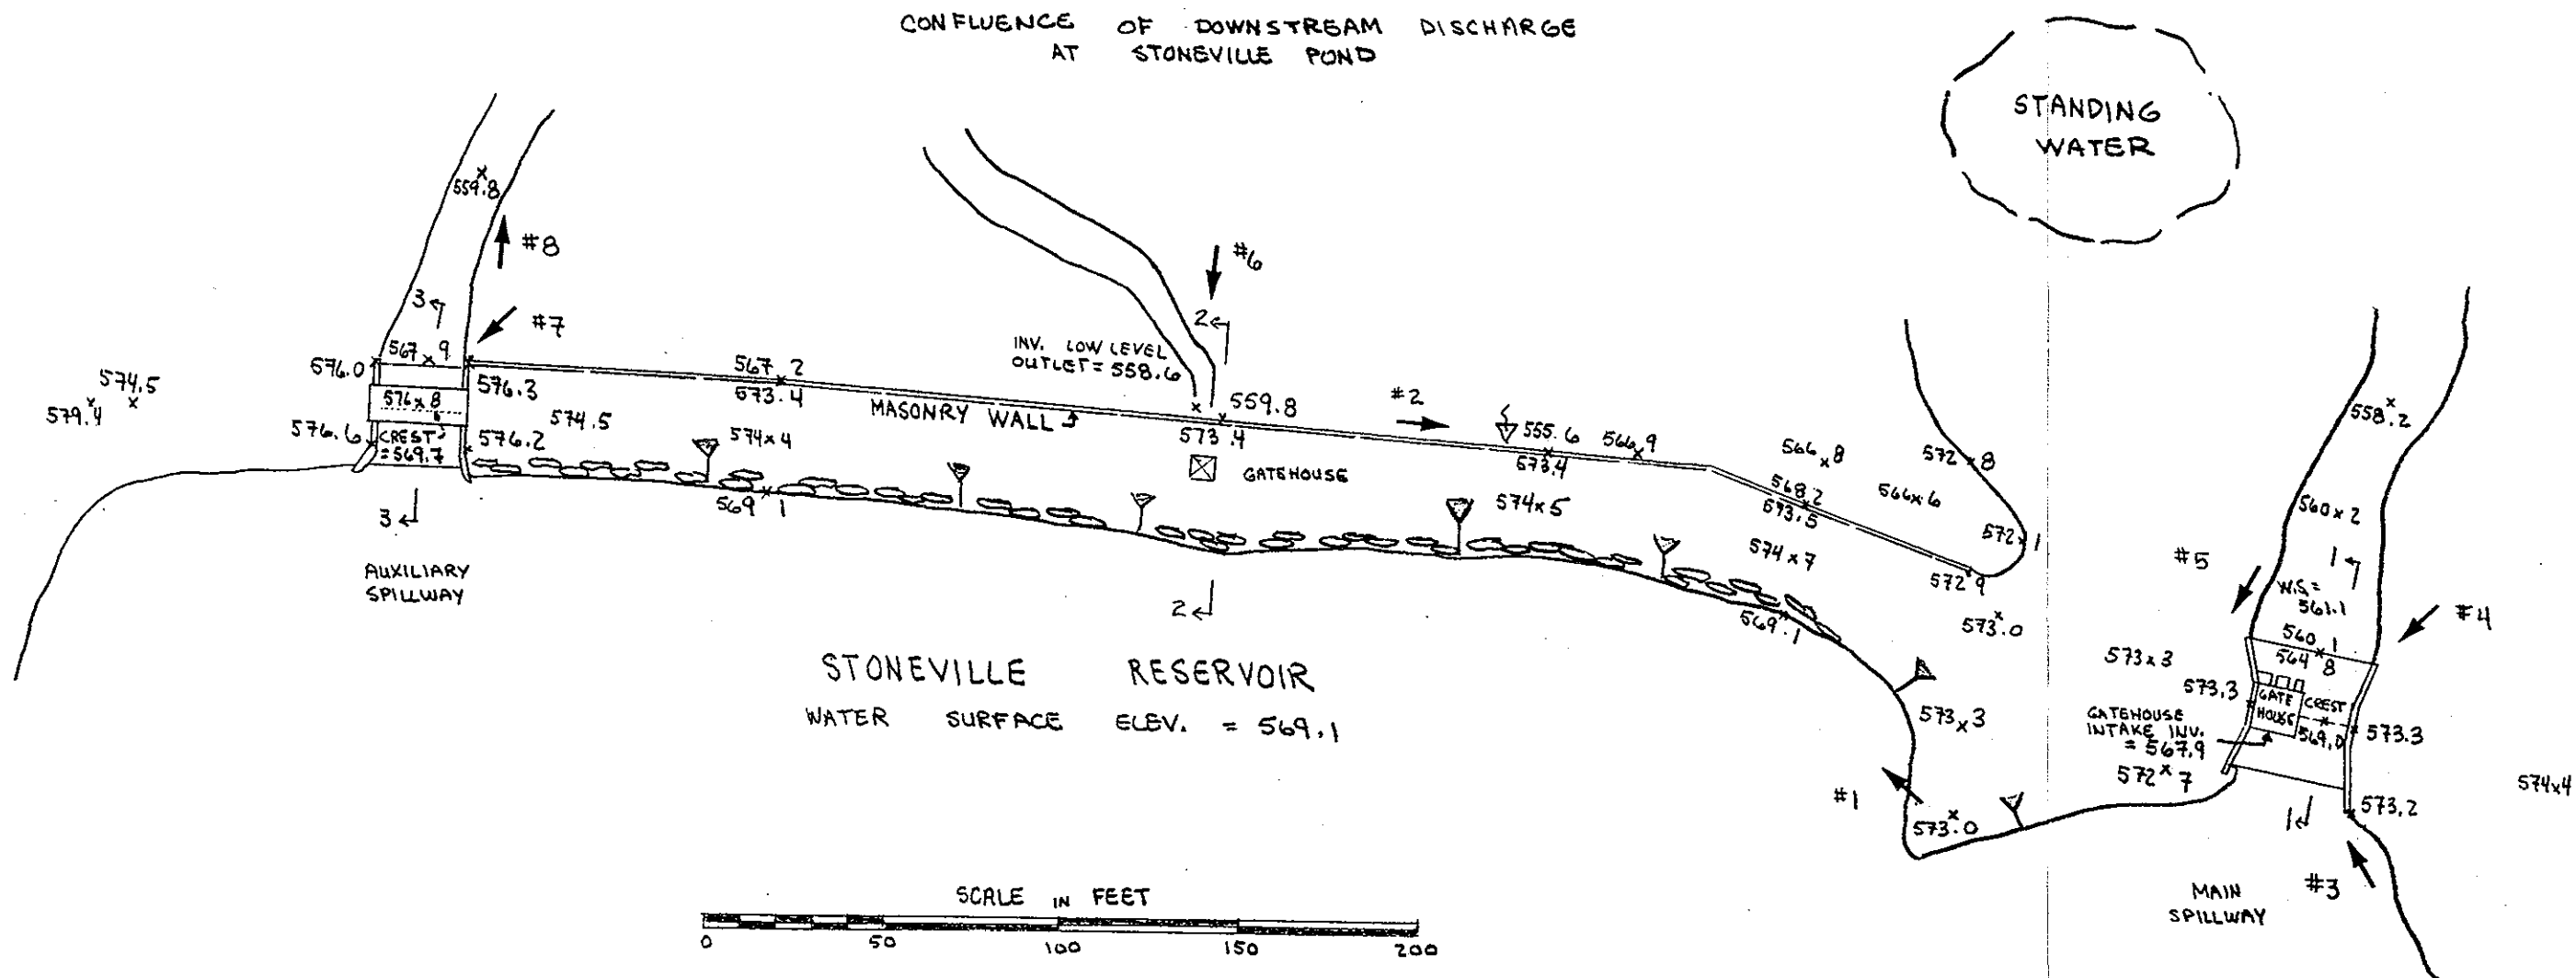
METCALF & EDDY, INC. ENGINEERS BOSTON, MA.	U.S. ARMY ENGINEER DIV. NEW ENGLAND CORPS OF ENGINEERS WALTHAM, MA.
NATIONAL PROGRAM OF INSPECTION OF NON-FED. DAMS	
UPPER STONEVILLE RESERVOIR DAM	
FIGURE B-1 PLAN OF DAM	
TRIBUTARY BLACKSTONE RIVER	MASSACHUSETTS
SCALE: 1" = 50'	DATE: JANUARY, 1979

1. ELEVATIONS SHOWN ARE REFERENCED TO ASSUMED BENCHMARK ELEV. 569.0 (MSL) ON MAIN SPILLWAY CREST
2. INFORMATION SHOWN BASED ON FIELD SURVEY OF NOVEMBER 16, 1978: "PLAN OF DAM RECONSTRUCTION OF SPILLWAY, UPPER STONEVILLE RESERVOIR" MARCH 6, 1950, BY N.E. POWER SERVICE CO.; "PLAN OF ELEVATIONS OF STORM SPILLWAY" NOVEMBER 15, 1955, BY N.E. POWER SERVICE CO.; AND "PLANS OF CONSTRUCTION OF FLOOD SPILLWAY" AUGUST 25, 1955, BY N.E. POWER SERVICE CO.
3. DENOTES SEEPAGE
4. #2 INDICATES LOCATION AND DIRECTION OF VIEW FOR PHOTOGRAPHS
5. SEE FIGURE B-2 FOR SECTIONS THROUGH DAM
